RAILWAY MUSEUM QUARTERLY

TRAINLINE

Number 10

Fall 2012

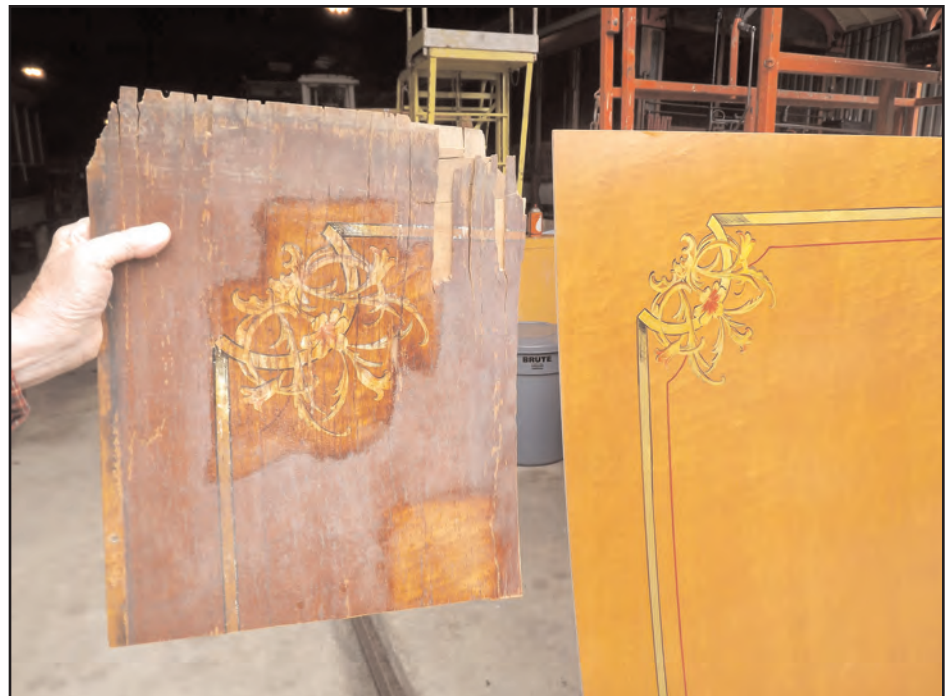
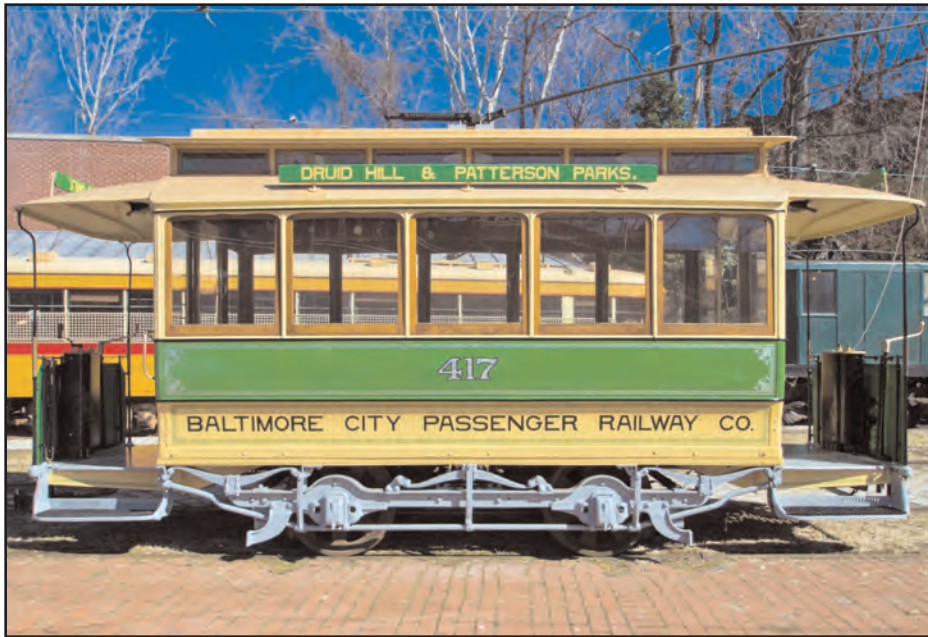
The fragment of original headliner at left became the template for the replication.

BSM, like most of the cars in the collection which were in outside storage for a time, it had a water damaged headliner. When 417 was in the process of being refurbished around 1971, the damaged headliner was removed and most of it discarded. Two

corner pieces were saved in order to provide a record of the car's ceiling decoration.

Most of our wooden cars have a 3-ply birch veneer headliner. I assumed, that like the other cars, 417's headliner was birch as well. Purchasing a 3-ply veneer that goes beyond the standard 4-foot width is the primary issue in replacing damaged ceilings in our cars. The material size needed, while non-standard, was of a size that I was certain that we could obtain, and a source for single ply birch of the appropriate size soon was identified. Laminating the single ply onto the plywood was how I planned to go.

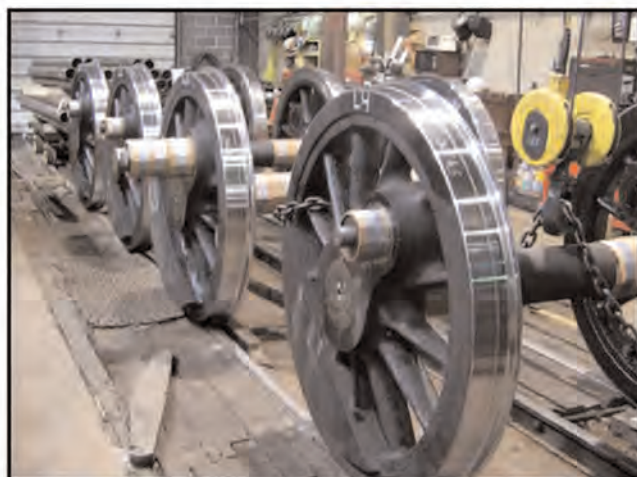
We can perform the full spectrum of work on driving wheels: tires, wheel centers, axles, crankpins. Our skilled machinists can and do handle any repair, overhaul, or replacement of these vital components.

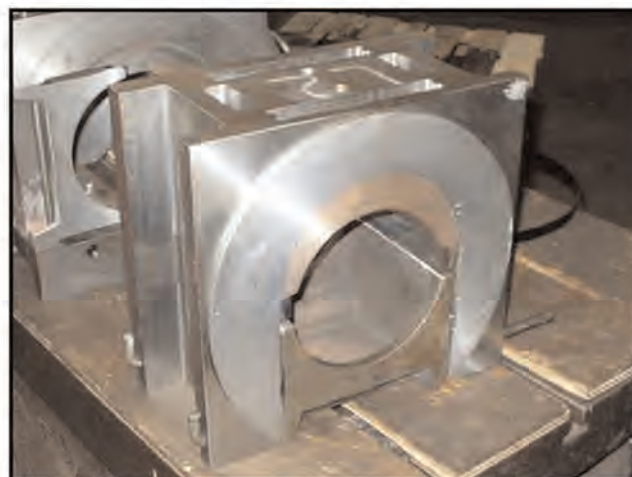
Our machinists have overhauled driving boxes by the dozen. Crown brass replacement, new hubliners, shoe & wedge faces overhauled, or completely new boxes are within our abilities.

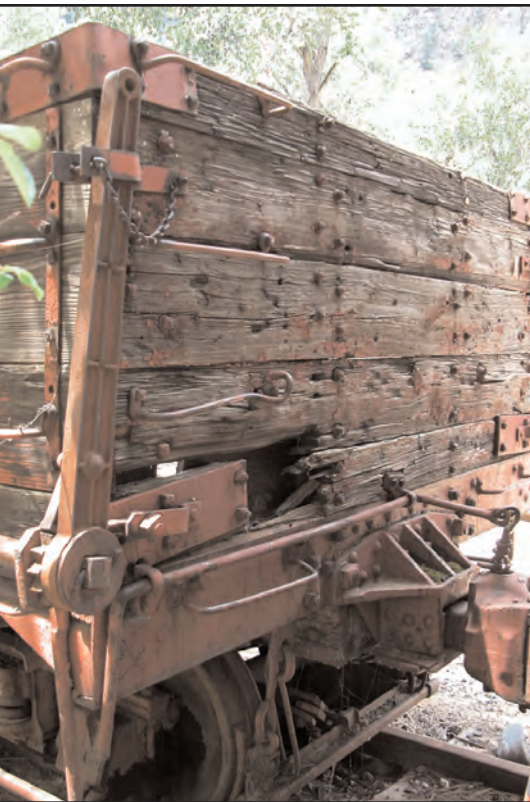
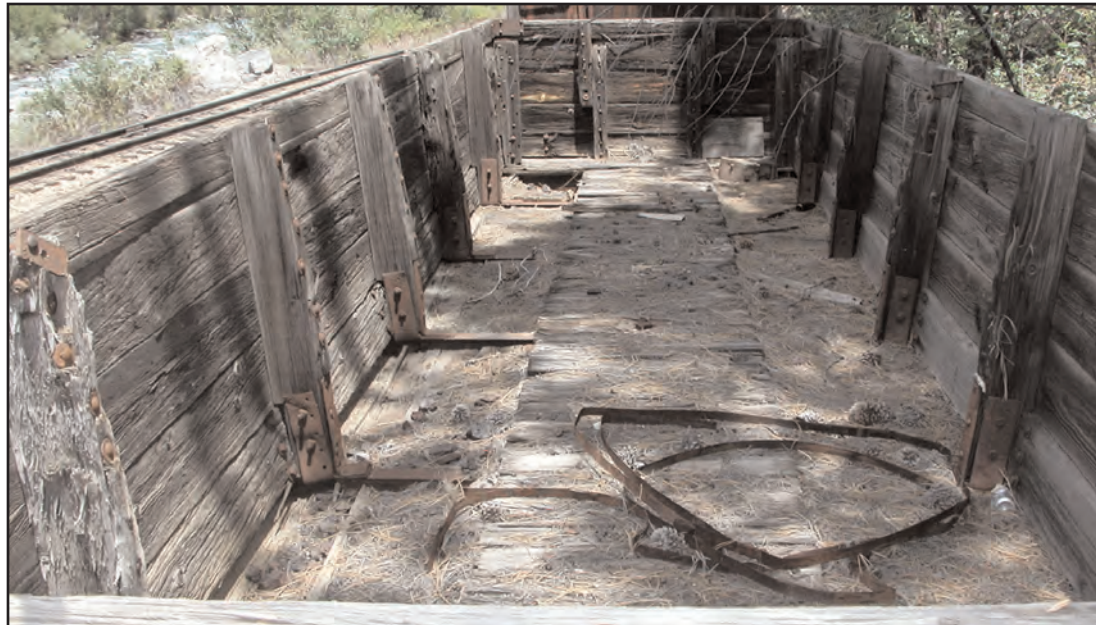
RESTORING D&RGW DROP BOTTOM GONDOLA # 871

Before photos by George Niederauer. After photos by Stefan Niederauer.

When originally built the 800 series cars were designed to carry coke. They had slatted coke racks that raised their sides to the height of boxcars and a roof walk but no roof. The winding shafts for the doors were hidden in the hollow A frame along the centerline. In 1918 the coke racks were removed and the winding shafts were moved to the outside sill. In the 1925 rebuild 5-inch side boards were added and under frames were stiffened with two 8-inch steel channels.

integrity of its final rebuild in 1925; in other words eliminate the repairs that used non-standard parts. Easily recognizable were the many shop repairs made during decades of service. As the car was dismantled all parts were analyzed for originality. If a part was determined a non-original type replacement, it was discarded and an original part substituted or replaced by the fabrication of an original copy. No attempt was made to duplicate repairs.

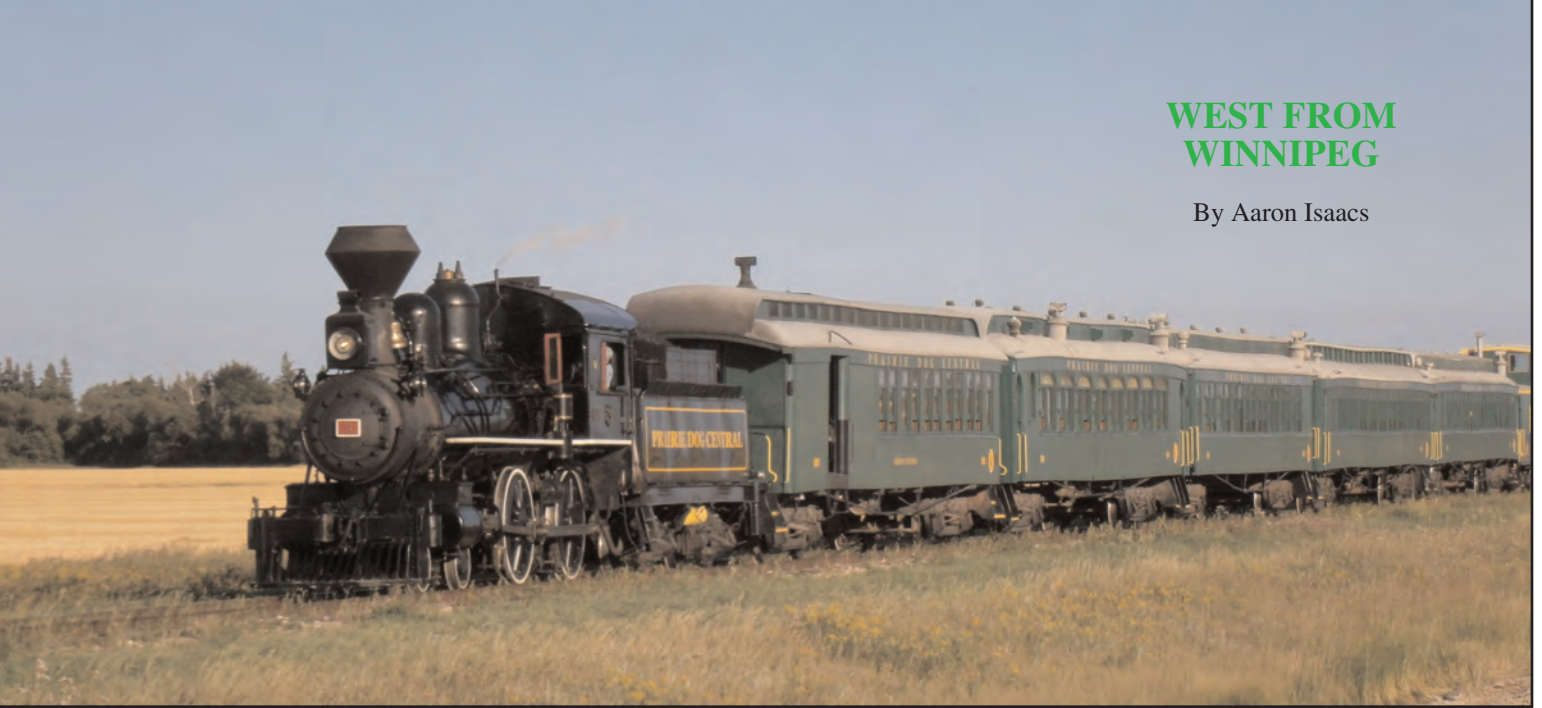
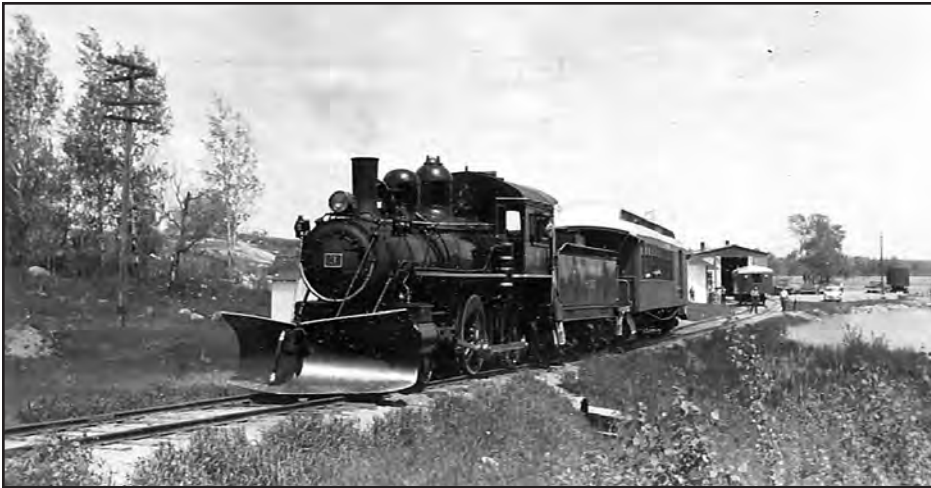
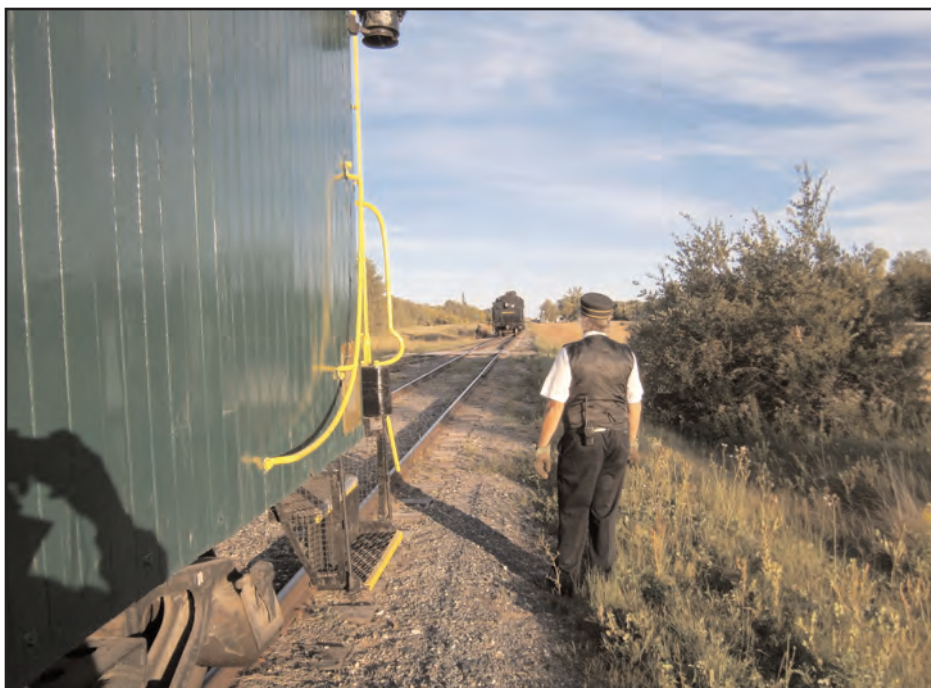
Winnipeg Hydro #3 about 1961 (above), and (top) reboilered and somewhat backdated on the Prairie Dog Central. The same combine trails it in both photos. Below: Wying the engine at Grosse Isle.

rolling stock. There is one unusual piece—a portable power plant owned by Canadian Utilities Limited (CCF 1928). Also, when the Prairie Dog Central reboilered #3 in 2004, the old 1909 boiler wound up here, where it makes an effective display.

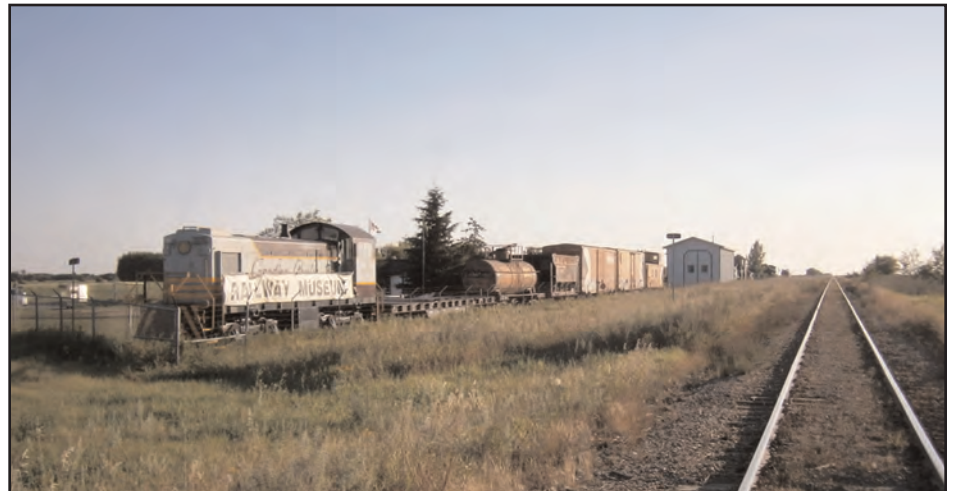
Overviews of the Saskatchewan Railway Museum, which occupies the former Hawker Station site. The Canadian National at right is still active.
