RAILWAY MUSEUM

Number 51

A Journal of the Association of Railway Museums

Spring 2009

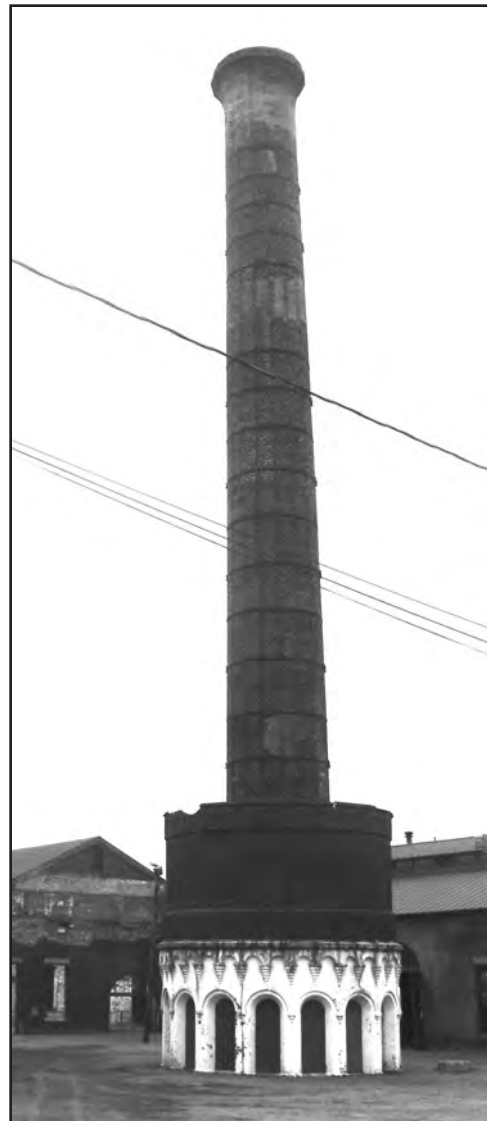
Above: All the shops' exhausts were routed through underground pipes to this single smokestack. The doors around the base are individual toilet stalls.

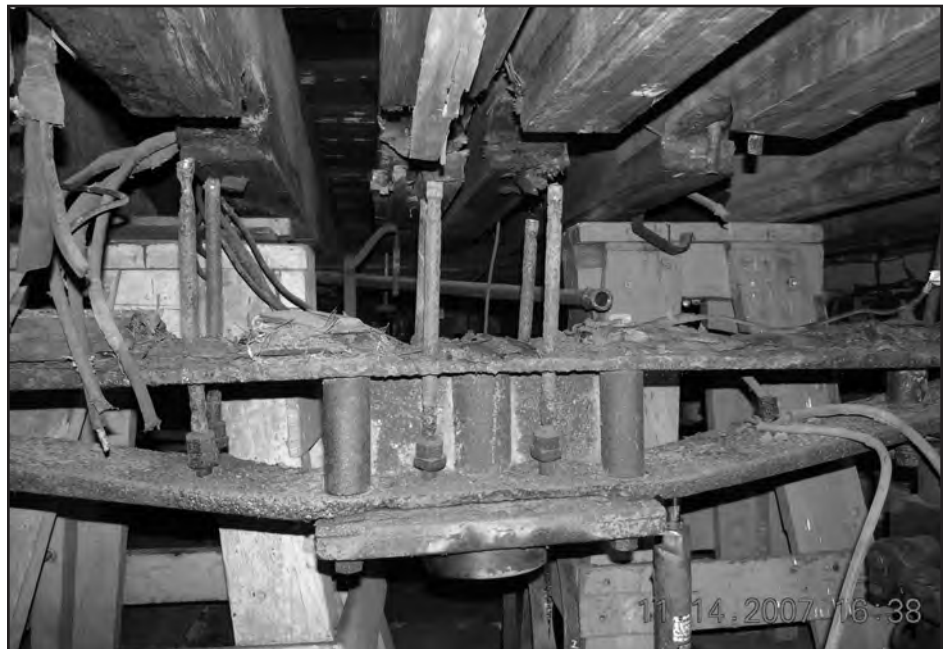
The original body bolster--note how it supports the eight sills that run the length of the carbody.

The long sills – as you look at the front of 100 from the no. 1 end, the sills are numbered 1 through 8 from left to right. The original no. 8 sill has been gone since 1965, replaced by a large spruce timber by an enthusiastic group of early Seashore restorationists. It has now been replaced by a 'new' no. 8 syp. Sill. The no. 1 sill had been fabricated and installed the week before.

We would love to have seen the huge machinery at Laconia Car Company which made the two tenons on each end of the sills. We didn't have that advantage. After carefully laying them out, we cut the tenons with a combination of circular saw (which could only get half-way through the 5 in. thickness), a very coarse-toothed

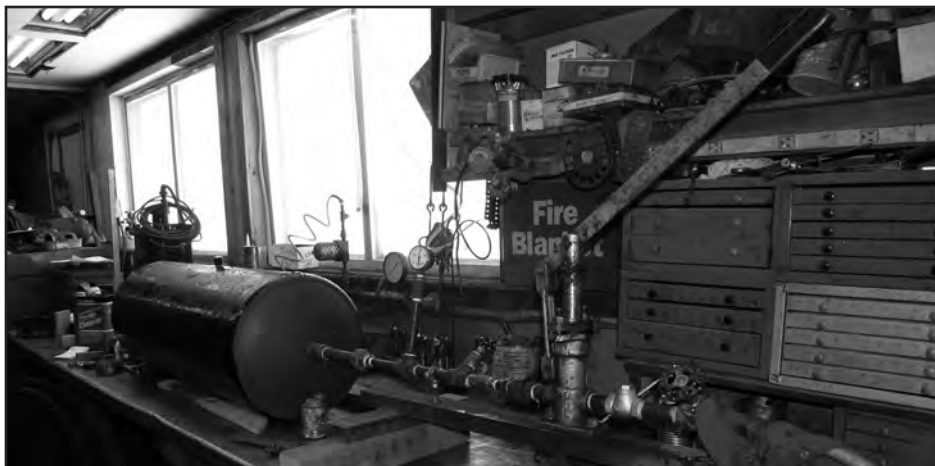
Hydro testing an air reservoir.

We set up the high-pressure test pump and found it leaked to the point it required repacking and a new check valve. Fortunately it is a simple-minded device and was easy to fix. Main reservoir no. 1 passed at 185 lbs. (1.5

times the operating pressure of 110 lbs.) We set up the other two tanks for testing but before they even filled with water, holes were found in each. On both the failure was under where the supporting straps were—not an uncommon thing. We also found that the auxiliary tank had been brazed in at least two places, not a good sign. Both tanks were unusable.
