HeritageRail Journal

January 2022

22 REPAIRING A WOOD PASSENGER CAR TRUSS

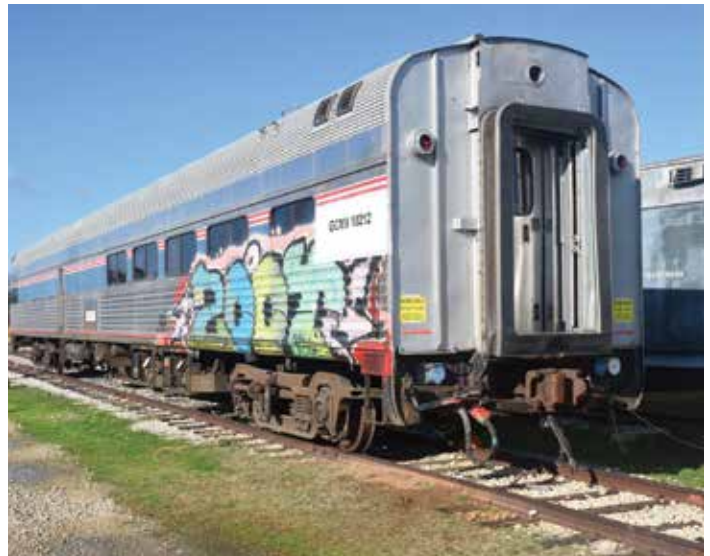
January 11, 2020: Kitchen side of the car as it first arrived at the ASTA Cedar Park yard. "Artwork" was acquired in Beech Grove. One of the sale conditions was that the car could not operate with Amtrak branding. The Amtrak branding consisted of a thin blue vinyl film overlaid with red and white striped vinyl. We want to put the car back to the original Sunset Limited scheme anyway.

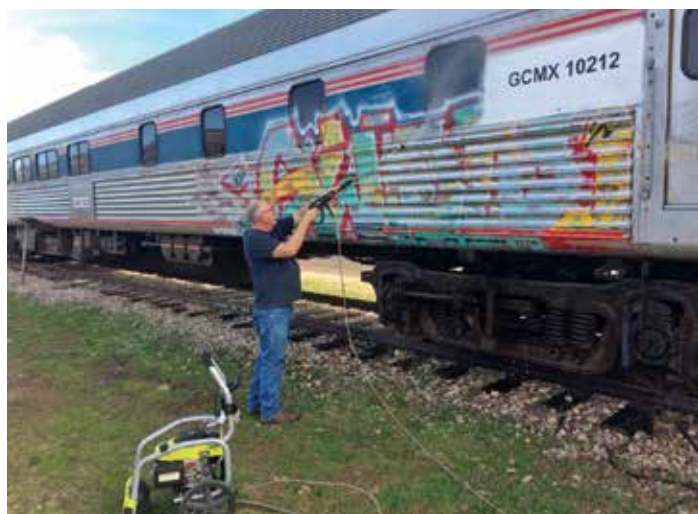
February 7, 2020: Chapter member Mitch Burk is pressure washing the passageway or the north side after an application of paint stripper to the graffiti. It took up to five applications of stripper followed by pressure washing to remove the spray paint.

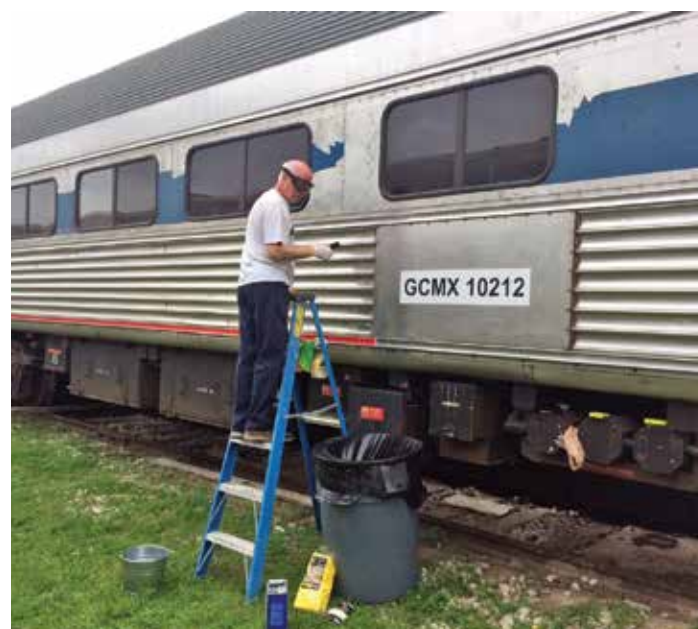
March 13, 2020: Here is chapter member Tom Marsh on the passageway side peeling the blue vinyl film from the window band after soaking it in acetone to soften the adhesive.

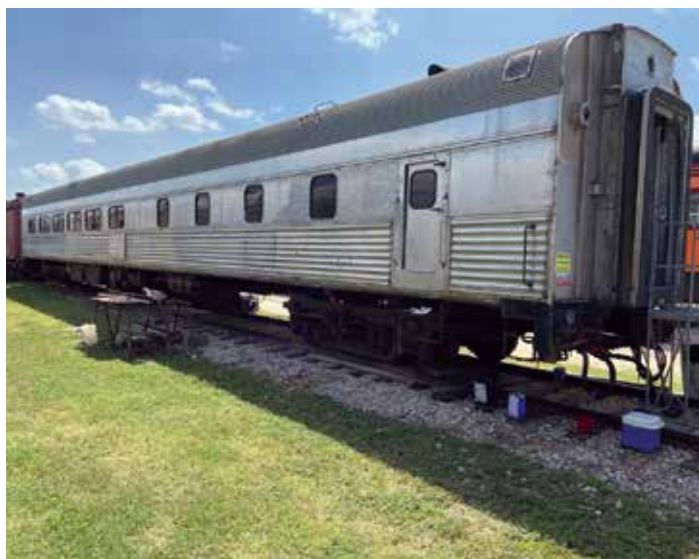
August 19, 2021: This is the passageway side after removal of the last graffiti and blue vinyl film.

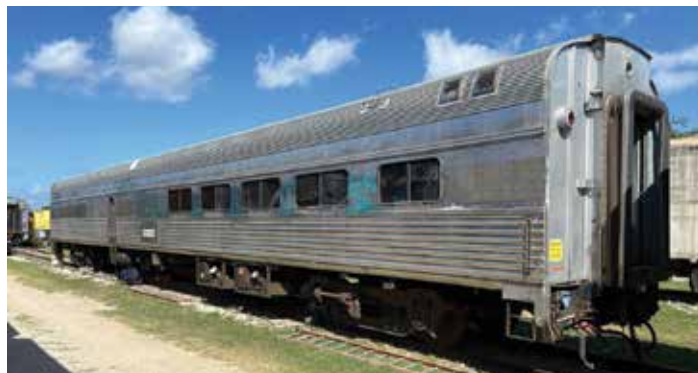
August 20, 2021: The kitchen side was much more problematic. The blue vinyl film was very weathered and had numerous cracks. Coupled with this is the fact that this is the sunny side and gets hot. Soaking with acetone was not practical. It evaporated immediately. I had to resort to scraping with a razor blade. This method left adhesive residue behind. It will need some cooler winter days to clean it off. At last the remaining blue vinyl film is gone, but not all the adhesive.

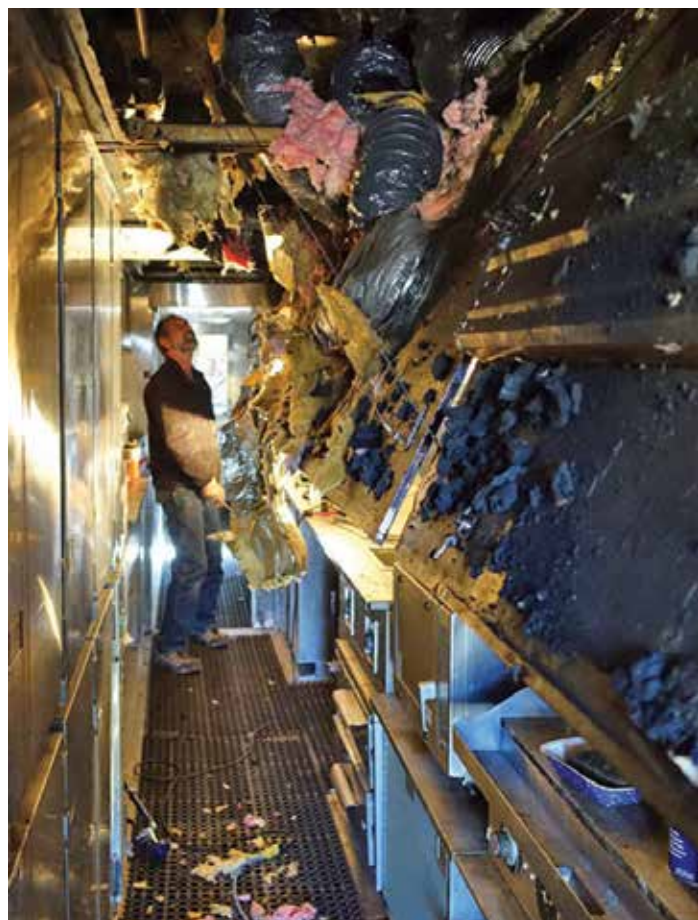
January 11, 2020: The interior of the car provided a great shock. Upon initial inspection it seemed to be in good shape, albeit a little worn and dirty. However, when I opened the ceiling access panels in the kitchen I received a major surprise: large quantities of fiberglass insulation fell out. Also see the next photo. Tom Marsh photo.

During the rebuild, the roof above the kitchen and serving area had been reinsulated with foil-faced fiber-glass which was inadequately secured in place, and had fallen down. Residential grade flexible a/c ducts had been used, and these had disintegrated, too. By far the worst problem was that the exhaust duct from the fan over the griddle had failed as well, allowing greasy smoke to permeate the ceiling plenum (space between ceiling and roof) in this area. There was no screen on the smoke jack in the roof and the smell of cooking grease had attracted a family of raccoons into the car while it was in storage at Beech Grove. It was, in a word, disgusting!

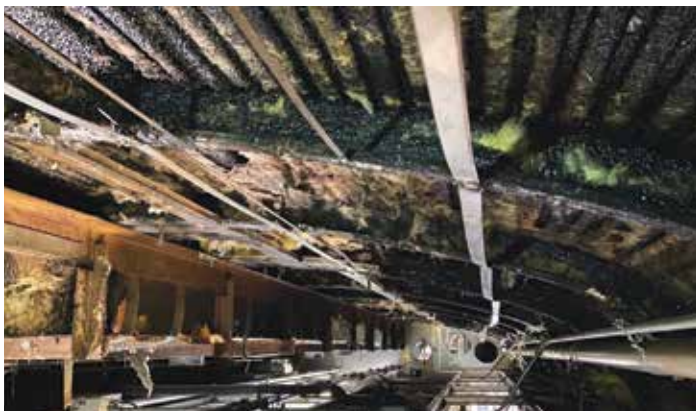
September 9, 2021: This is a view inside the ceiling plenum above the passageway looking toward the A end after the clean up was completed. The underside of the roof was coated with asphalt when built. The main a/c supply duct is on the left and the three holes in the bulkhead are (L to R) the griddle exhaust and two return air duct connections. New insulation will be inserted between the ribs and secured with wires.

The first task in putting the car back in a usable condition was to clean the ceiling plenum. It was decided to engage professional help. This was not a job that I felt able or wanted to take on. I was able to locate a remediation company in Cedar Park that was willing to take on the job, although it was two months between first contact and work commencing in mid-August. It took a crew of two about ten man-days (working mainly in the cool of the mornings) to remove the remaining insulation and get the surfaces to pass the "finger test." That is where one can run one's finger along the surfaces and not pick up any dirt. I removed one of the windows while the contractor was cleaning the ceiling plenum to investigate how the glazing system goes together. I covered the hole with a piece of plywood and had to remove the window curtains in the process. As an experiment I had one of the two curtains dry-cleaned and was quite happy with the result.

Now that the ceiling plenum is as clean as can reasonably be achieved, the next task will be to reinsulate the underside of the roof and the main a/c supply duct. This too will be outsourced to a suitable contractor. With new insulation in place, new flexible ducts will be installed. There are short flexible drops from the main supply duct to the registers in the ceiling panels of the kitchen and passageway. The two 10" return air ducts from the return air filter grille above the A end door to the mid-car air handler need replacing. Last, but not least, there will be a new exhaust duct from the griddle extractor fan to the roof jack, including a small animal screen. We can then have a commercial HVAC company clean the air handlers, evaporator coils and condensing units. The HVAC system will need to be checked for proper operation along with the refrigeration equipment.

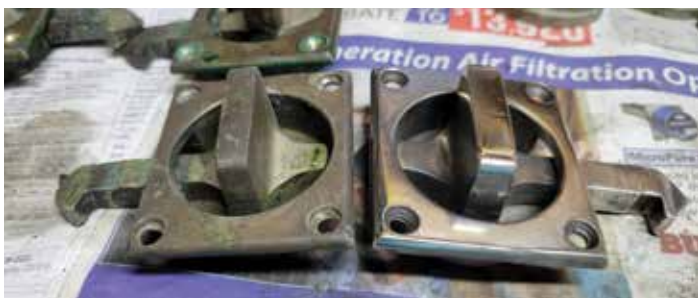
Compare the latches before and after cleaning.

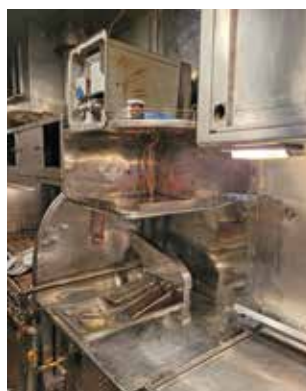
The fryer and shelves after restoration.

When I started this project (way back before the pandemic hit) I began with the deep fryer, ended up taking it home and completely rebuilding it. The restored deep fryer has been reinstalled, and it really made the rest of the kitchen look shabby. I was able to remove the toaster shelf and clean up the damage from the bad welding, which incredibly hadn't damaged the stainless steel wall behind

belongs in the car. He even added a bit of Art Deco flair to it with a wire railing to keep things from sliding off the shelf. That 3-foot section of the car had the most modifications and the most damage, but the restoration has been completed in that area from floor to ceiling. Even the water heater itself has been restored to service for when the car is put back online. My thanks to Howard for jumping in and saving the PLA a ton of money in the process.

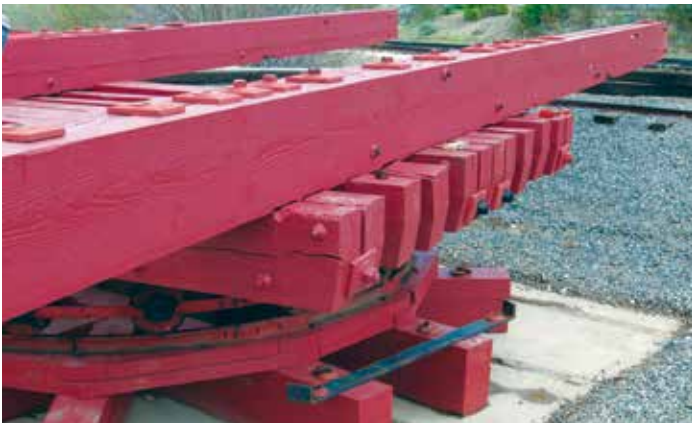
The center pivot with side sills.

The turntable is a visual lesson in physics. In the first place, it is a bridge. Unlike a conventional bridge, which spans a void between its abutments, the turntable bridge extends outward over empty space in opposite directions from its central support. This is because the turntable must rotate, and its central support rests on a large pivot. But extending those bridge sections outward from the turntable's central support is an engineering challenge. In the case of the NSRM turntable, the ends are suspended from a central tower. Our turntable is copied specifically from plans developed by the Southern Pacific Railroad about 1900, but its design is fundamentally the same as wooden turntables built half a century earlier. The advantage of a turntable built to this design is that it is composed primarily of wood, which was readily available. Also, because the bridge structure is primarily above the track, it requires only a shallow excavation to clear the portion of the turntable below the track.

Another way in which the turntable is a visual physics lesson is the means developed for turning it. The entire weight of the turntable and any piece of rolling stock that is being turned must somehow be overcome so that it might be swung around on its pivot. This is done by applying leverage. In a common lever and fulcrum, a relatively small force applied to the long end of a lever can lift or move a heavy weight placed closer to the fulcrum. In the turntable, this lever is placed on its side, so the weight is not being lifted, but simply moved sideways. The weight of the table and its load is concentrated on the pivot, which is the fulcrum, and thus it can be moved by a much lighter force applied at the ends of the table. In the case of NSRM's turntable, the pivot, or fulcrum, is the small ring-rail under the center of the turntable. Its diameter is the width of the turntable to provide stability. It would be far easier to turn the turntable if it was a mere point at the center, but there would be nothing to keep the table from falling over sideways, and the friction on that pivot would be immense.

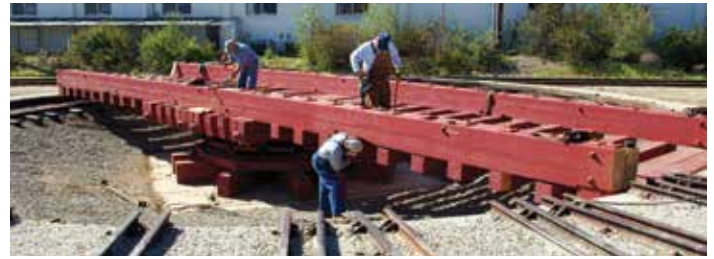
Rebuilding the turntable deck.

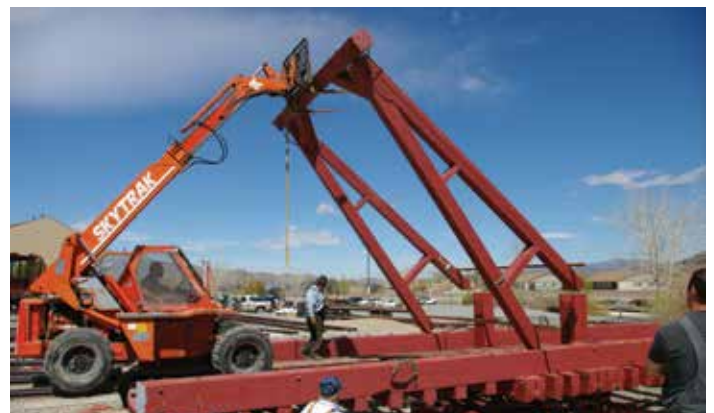
Hoisting the A frame into place.

a locomotive or car was moving onto or off the table. Early examples of gallows tables show only a fixed shelf for the turntable to settle onto during loading. The purpose of the rail and wheels was to support the ends of the table so that the rails on the table remained at roughly the same level as the adjacent track. If those wheels remained in contact with the ring rail under load, it was difficult—if not impossible—to turn the table.

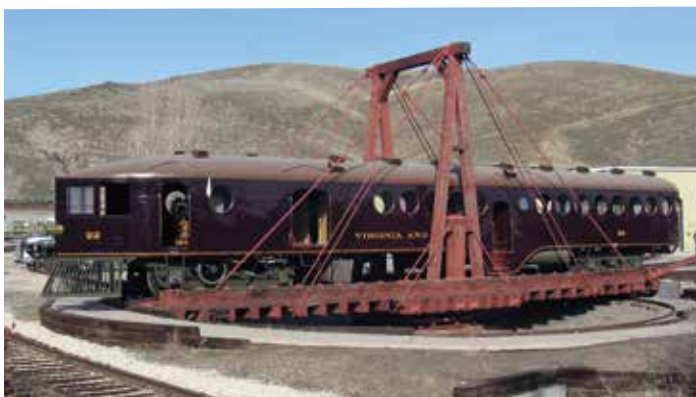
The McKeen car on the table.

After placing the McKeen car in service a new problem arose with the turntable. The wheels of a locomotive are generally evenly spaced the length of the locomotive, distributing the load over the length of the turntable. Furthermore, the general design of our locomotives is such that the locomotive's weight is placed closer to the center of the turntable than at the ends. The McKeen, however, is supported on trucks at the ends, much like a conventional freight or passenger car. In fact, the wheel base of the McKeen car is just a few feet shorter than the length of the turntable and the ends of the car hang over the ends of table.

The McKeen is a heavy car, and with the trucks much farther apart the weight is concentrated at the extreme ends of the table. When loaded onto the turntable, the McKeen forces the ends of the turntable downward and makes contact with the outer ring-rail unless there is constant attention given to adjustment of the truss rods. If the table is adjusted too tightly, loading is problematical as the loading end rises up into the air as the front truck crosses over the center and tips the table. This situation requires a run at the end to get the rear truck over the high rail and a sudden stop to prevent running off the end. The entire situation is getting out of hand.

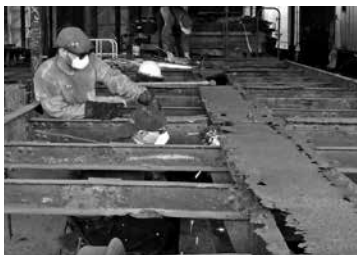
Volunteers remove bad metal from the flat car frame.

The Andrews trucks were similarly evaluated, and badly wasted components were replaced with new steel. Castings were repaired where possible, or replaced with fabricated steel parts. The wood
